Home Inspections

Re: Visual Inspection & Laboratory test for evidence of existing contamination associated with Chinese Drywall; performed on September 29th, 2009 at Example Way, Ruskin, FL. 33570

Suspect Chinese Drywall Analysis Fourier Transform Infrared Spectroscopy (Mid-Infrared)

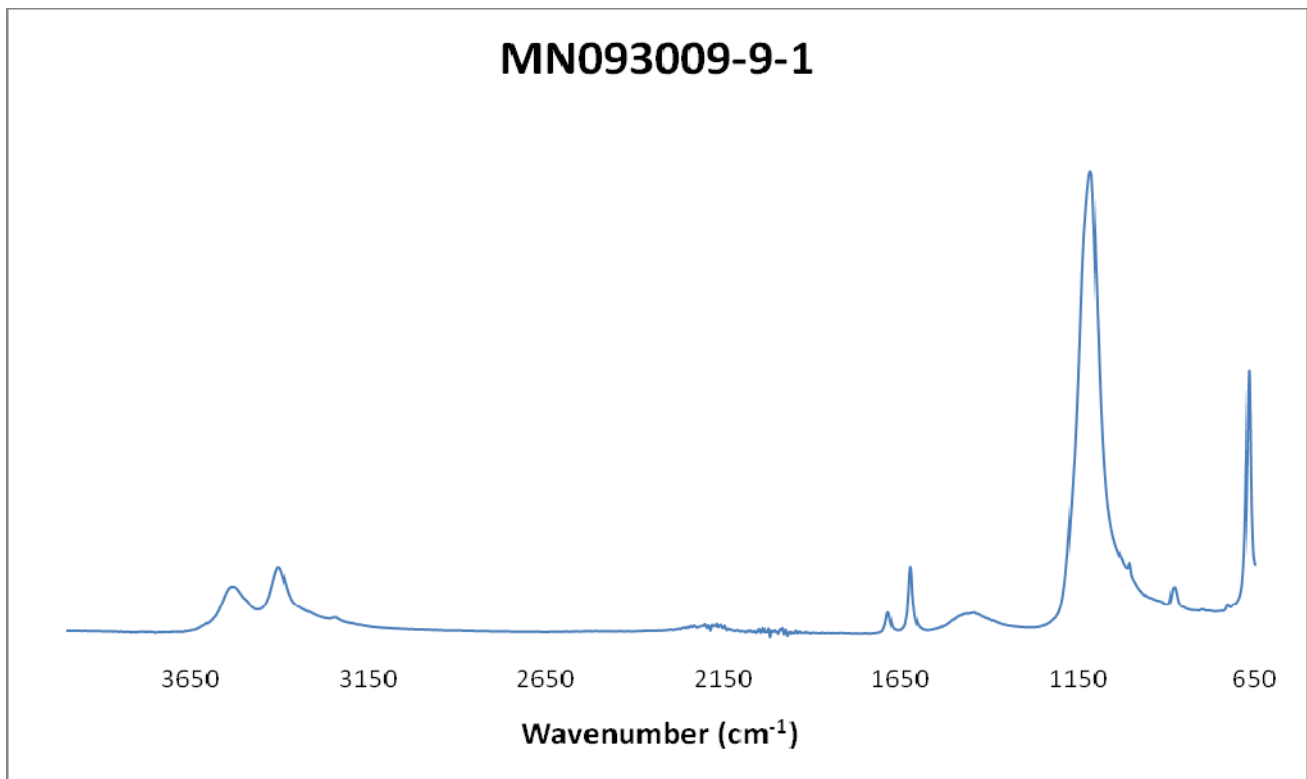
Sample ID: Master Bedroom Back Wall

Results: **Congruent** The FTIR spectrum of the sample is consistent with the spectral characteristics and peaks identified in contaminated Chinese drywall reference materials.

Figure. Spectral Fingerprint of sample. Each spectral fingerprint is generated from 34,010 data points. The data points are used to determine spectral congruency with known chinese drywall reference materials. Please note that the above figure is a condensed graphical representation of the averaged data scans and not intended for intersample comparisons.
